EVALUATION OF BAK-14 HOOK-CABLE
SUPPORT-SYSTEM MODIFICATIONS

FINAL REPORT

Test Period: 11 December 1974 - 31 July 1975

DDC 07
1-2
REPORT NATF-EN-1135

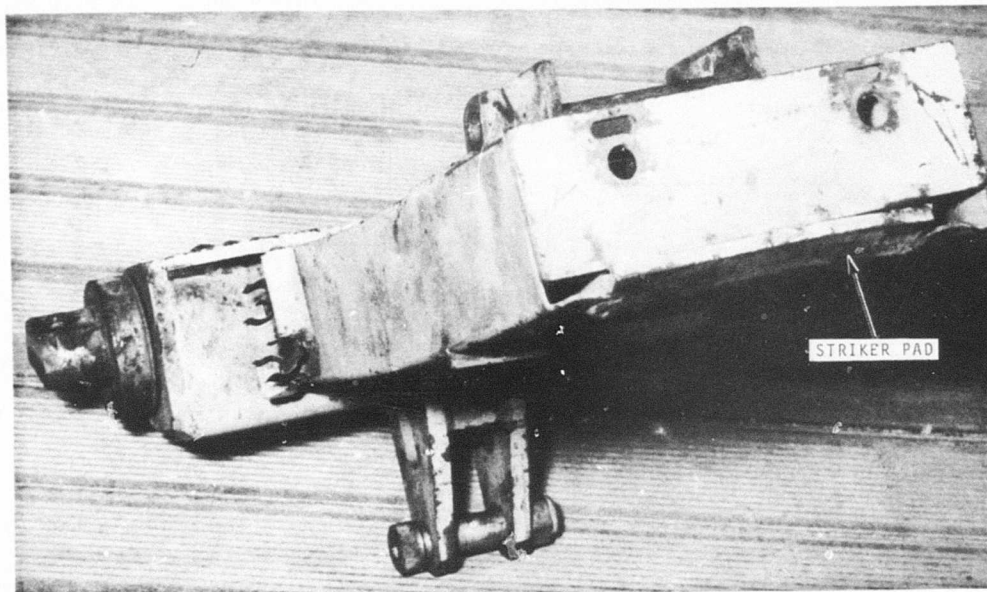
FIGURE 5 - BAK-14 TEST-CONFIGURATION SUPPORT ARM

L. TEST CONFIGURATION SUPPORT ARM (see Figure 5): The test configuration support arms were exposed to a total of 136 aircraft tests in runway support-box locations 1, 6, and 7, and to 114 aircraft tests in locations 2, 3, 4, and 5. Support-arm bending caused by high inertial loads developed in the torsion spring-loaded support arm from impact of the aircraft tire was the most serious problem encountered during the tests. The principal effect of the bending was to disable the latch-actuating mechanism and air cylinder by causing interference between the pivot assembly and air cylinder. The permanent bend damage is probably the result of metal fatigue which was first detected after event 59. The physically identical group of support arms used in these tests was previously exposed to approximately 302 aircraft tests (references (d) and (e)).

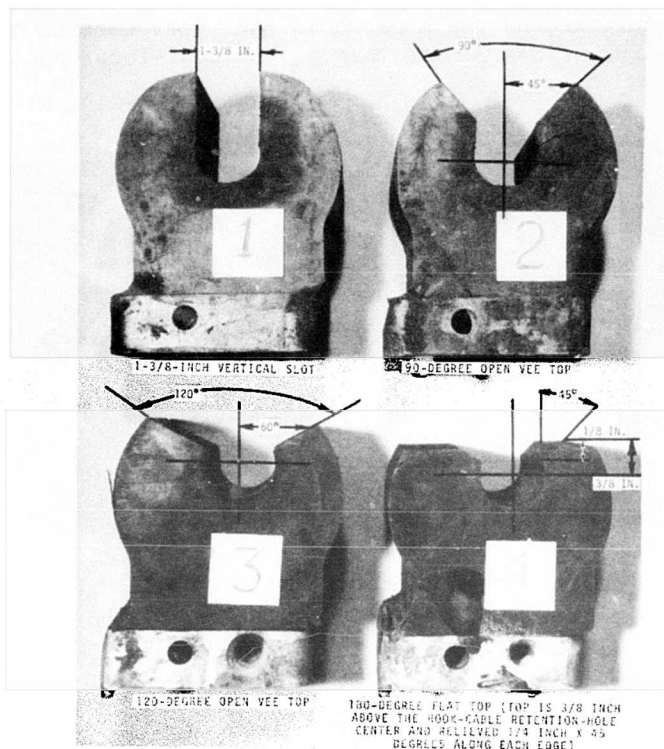
FIGURE 6 - MODIFICATIONS OF THE STANDARD SUPPORT BLOCK

1. MODIFIED SUPPORT BLOCKS: The modified support blocks (Figure 6) were designed to decrease block damage when the supported hook cable is extracted during aircraft arrestments at extremely low temperatures, and to hold the restrained hook cable in the support blocks when the system is cycled (raised and lowered). The modifications consisted of the removal of the neoprene rubber from the top of the block with the aid of a band saw to reduce block grip on the hook cable. Support blocks were fabricated incorporating four modifications in which the hook-cable openings on the blocks were progressively increased from a vertical slot to a wide-open flat top.

D. The deflection of the optimum open-top support block (modification No. 4) was less than that of the standard support block during arrestment extraction of the hook cable but was greater than expected and may be indicative of support-block base-separation damage at extremely low temperatures. (Paragraph IVC2)

B. Install and evaluate support-block modification No. 4 under extremely low temperature conditions.

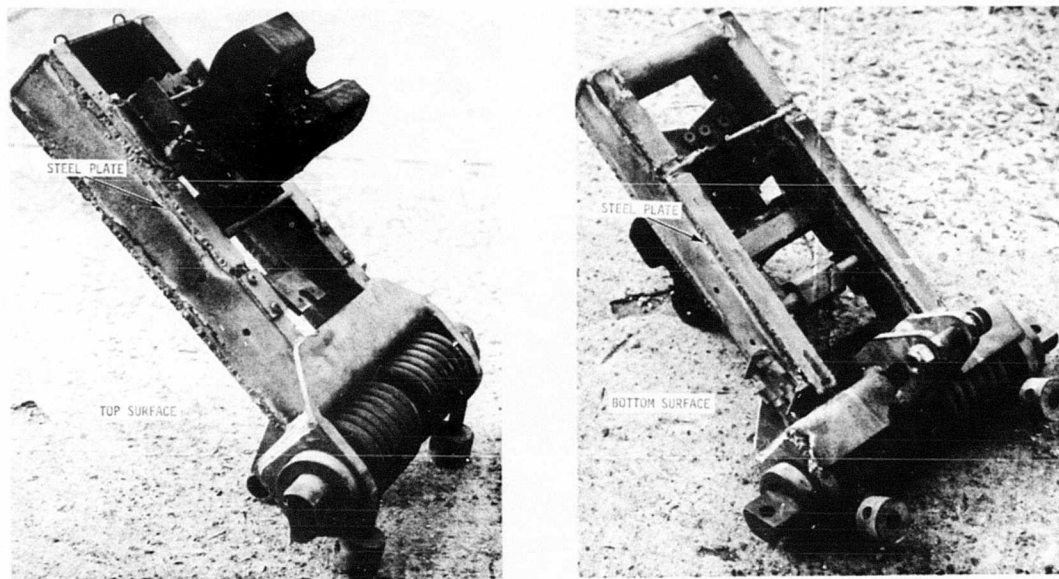
FIGURE 11 - REINFORCED SUPPORT ARM

K. REINFORCED SUPPORT ARM (see Figure 11): The reinforced support arms were deliberately exposed to a series of 12 high-speed tramples with the A-4 aircraft at speeds of 88 to 154 knots and 10 arrestments of the A-4 aircraft at engaging speeds of 96 to 134 knots. Inspection of the reinforced support arms after completion of the aircraft tests disclosed no bending or impact damage.

I. The operation and condition of the reinforced support-arm were satisfactory after 22 aircraft tests. (Paragraph IVK)

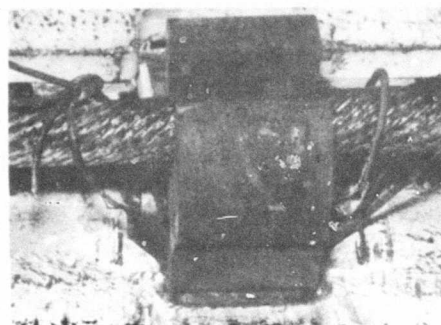
FIGURE 12 - CHAFED COATED RESTRAINT WITH THE STANDARD SINGLE-LOOP REEVE

1. STANDARD SINGLE-LOOP-REEVE RESTRAINT (Figure 12): The axial movement of the hook cable caused by the aircraft trample shifted the looped cord away from the side of the support block. The extended loop was then exposed to chafing contact against the support-box cover when the support arm was depressed by the aircraft trample. Seven single-loop-reeve restraints failed or were damaged in this manner during the 18 aircraft tramples.

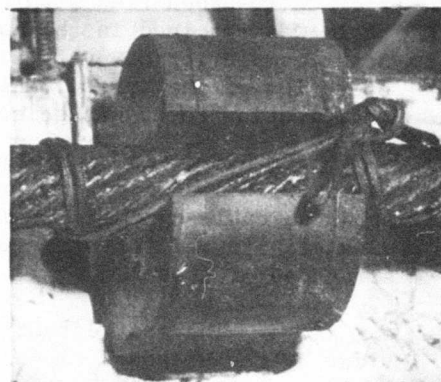
FIGURE 13 - DUAL-LOOP-REEVE RESTRAINT SHIFTED OUT OF POSITION

2. DUAL-LOOP-REEVE RESTRAINT (Figure 13): Two failures occurred during completion of 30 aircraft tramples with the dual-loop-reeve restraint; namely, a failure of the restraint cord, and a failure to retain the hook cable in the modified open-top support block although the restraint was still intact. Both failures may have been caused by the decreased strength and the increased elasticity of the dual-loop reeve which divides the hook-cable restraint load among four cords compared to eight cords in the standard single-loop reeve and the cross-loop reeve.

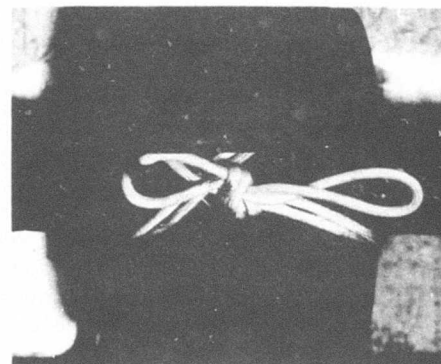
FIGURE 14 - CROSS-LOOP-REEVE RESTRAINT AFTER ELEVEN TRAMPLES

3. CROSS-LOOP-REEVE RESTRAINT (Figure 14): The cross-loop-reeve restraint was not shifted out of position by the axial movement of the hook cable as was the standard single-loop-reeve restraint. It, therefore, was not subject to chafing by the support-box cover. By comparison, only minor chafing damage was experienced during the completion of 77 aircraft tramples with this restraint configuration. High-speed motion-picture coverage indicates that the most effective restraint and retention of the hook cable was provided by the cross-loop reeve.
